## CAMPUS OBSERVATIONS

# Bonita Canyon Elementary School

1 Sundance | Irvine, CA 92603  
Site Analysis

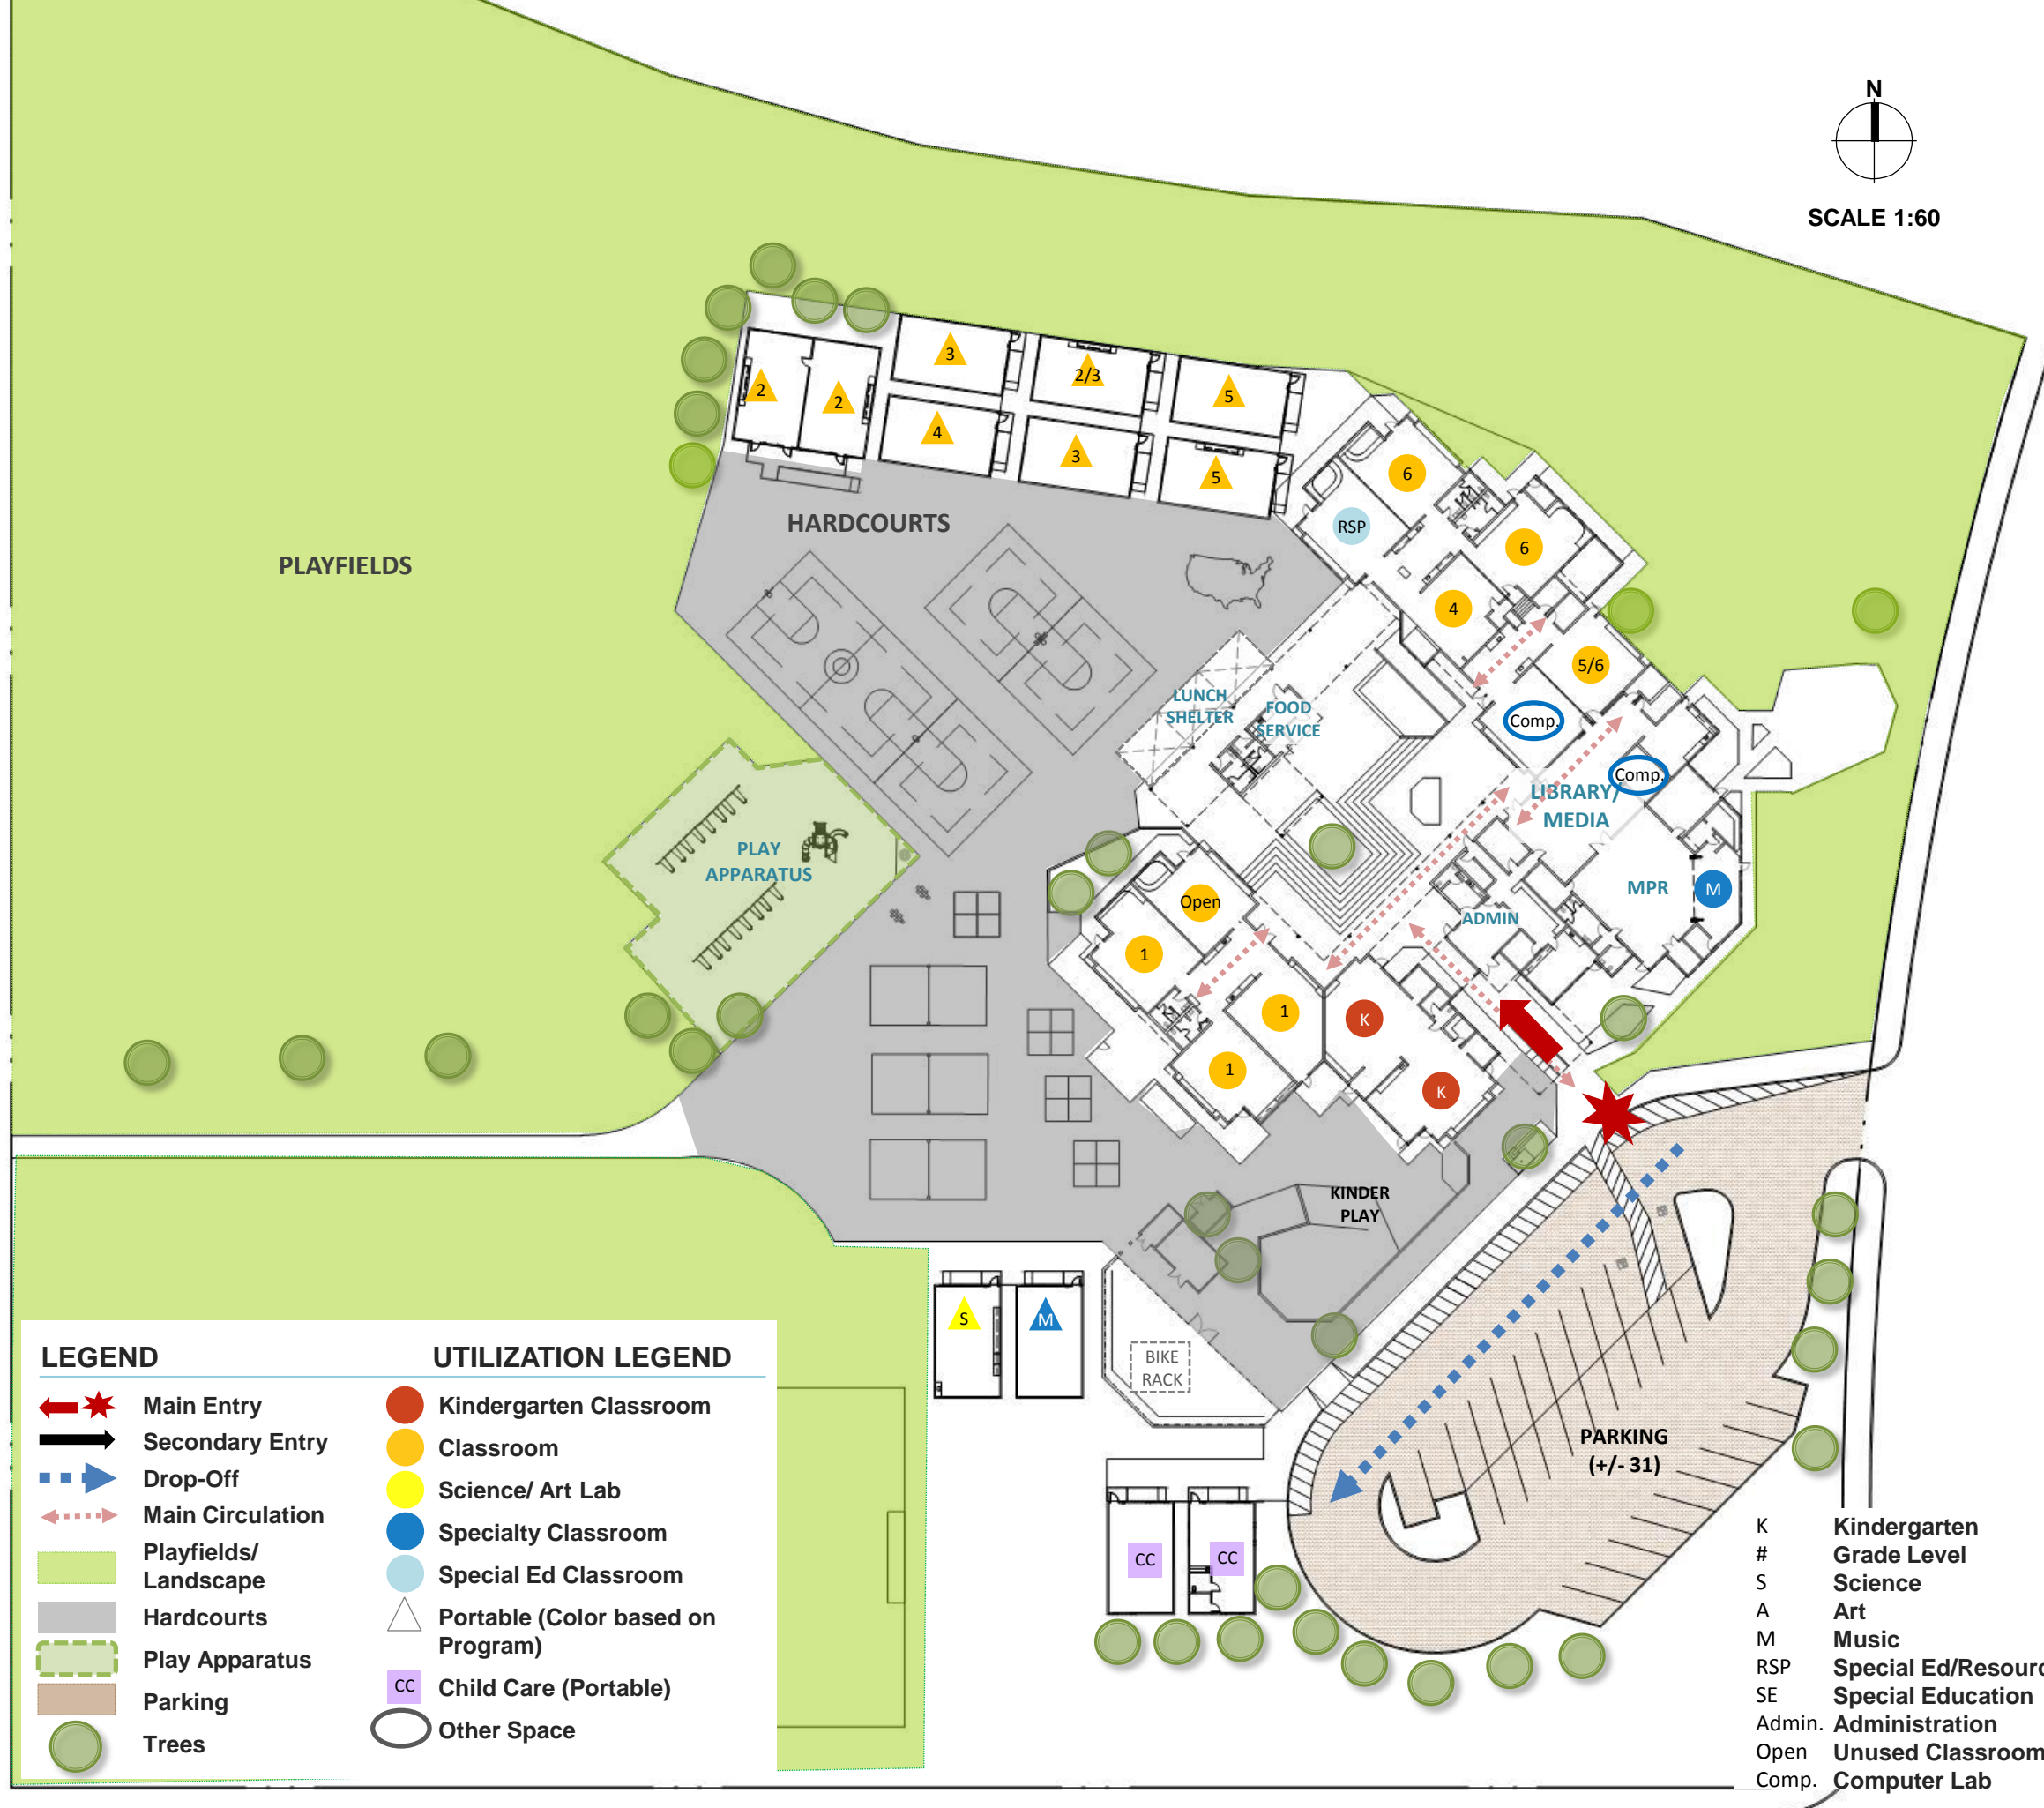
PLAYFIELDS

HARDCOURTS

PLAY APPARATUS

LUNCH SHELTER

FOOD SERVICE

LIBRARY MEDIA

MPR

ADMIN

KINDER PLAY

PARKING (+/- 31)

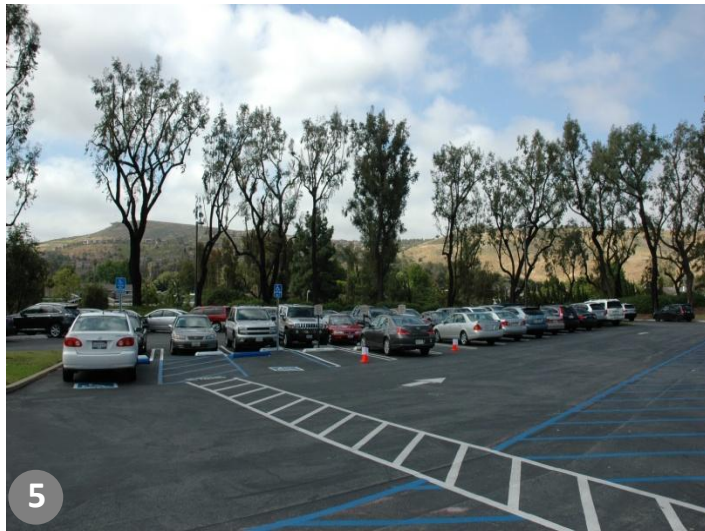
Parking

- Small parking lot; does not adequately accommodate staff and visitors, particularly on days with Music and Science
- Abundant foot traffic before and after school; can be safety issue, as traffic moves somewhat quickly on adjacent roadway (Turtle Rock Dr)

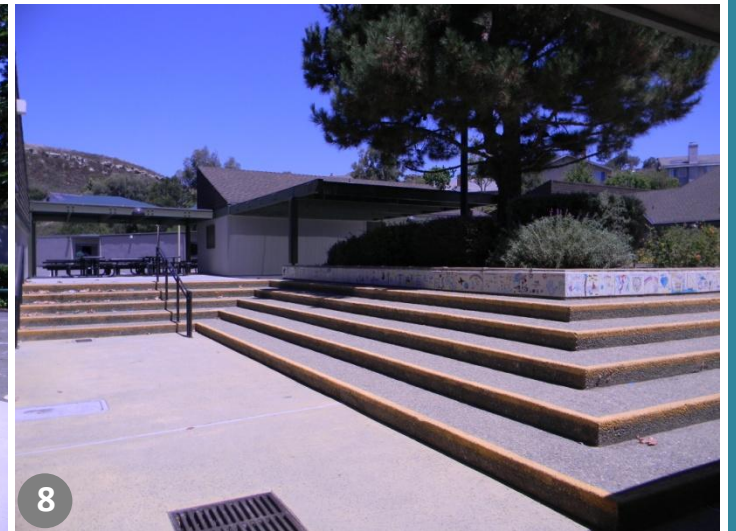
View toward Food Service

- Area seems small with potential for congestion
- One (1) entry/exit
- Current layout, setup, and presentation of food is described as not providing a sense to students and parents that nutrition is important

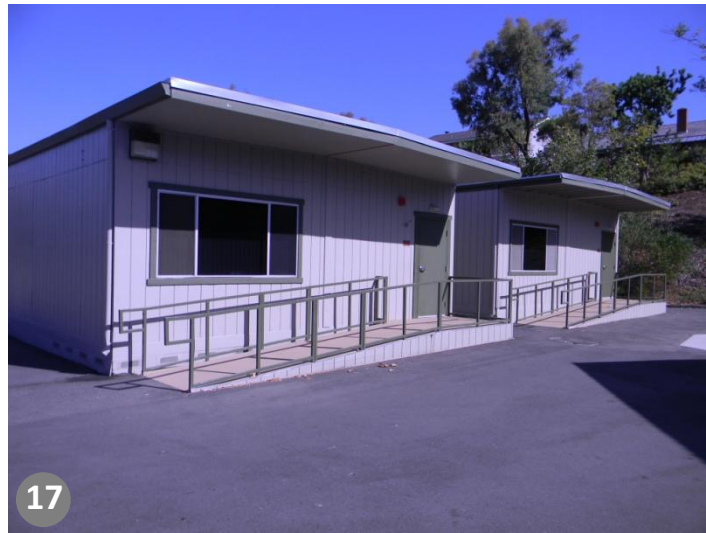
- Portables have limited access to computers; will be using laptop carts to attempt to address issue and will need more wireless accessibility
- Difficult to accommodate all computer lab needs due to scheduling issues; adding wireless lab to increase flexibility

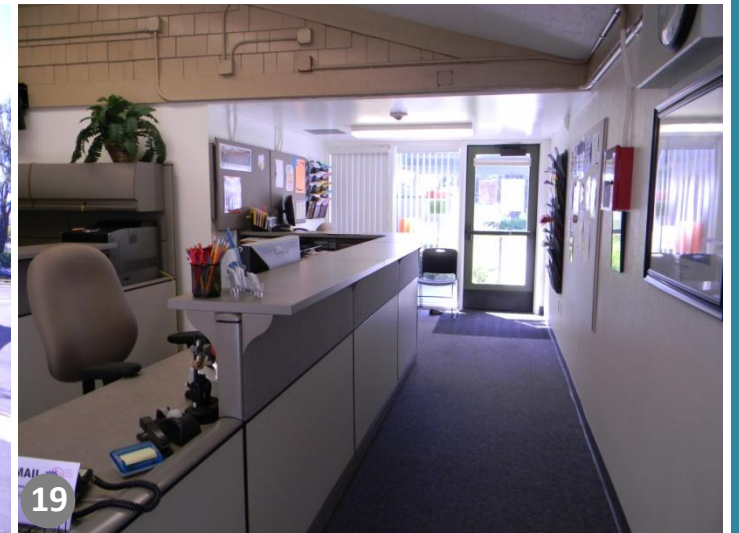
Main Office

- Work environment described as productive (since modernization & improvement of front office and large conference room), generally providing more space for teachers to work
- Front office seems small/narrow and somewhat cramped

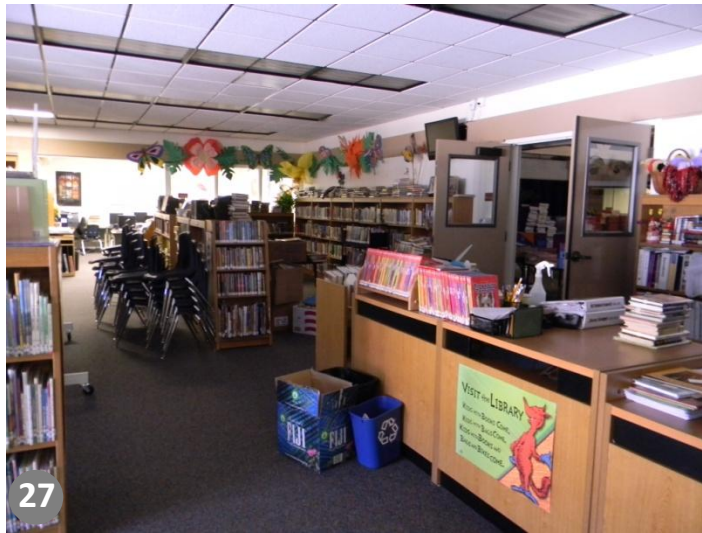
Library

- Adjacent to MPR; not directly adjacent/easily accessible to all classrooms
- Described as “crowded but functional”

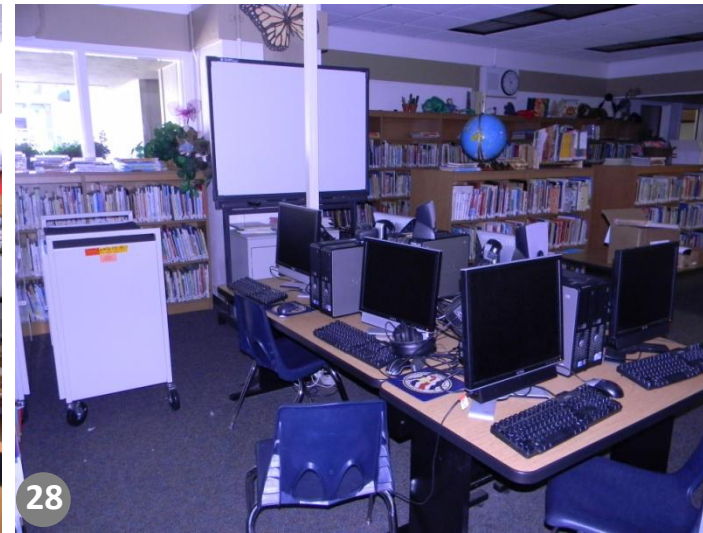
Computer Stations in Library/Media Center

- Currently, small number of computers in

library, as well as computer lab adjacent to Library; difficult to accommodate full class

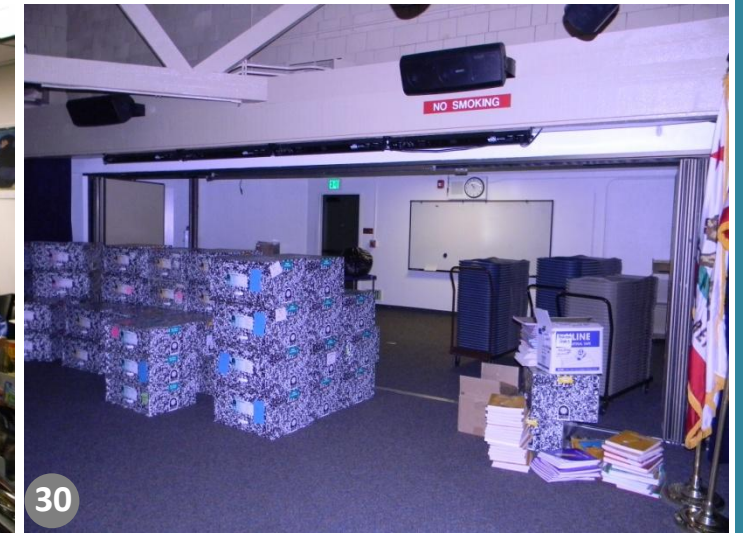
MPR Stage

- Cannot open up space into central courtyard or outdoor amphitheatre
- Stage used as Music classroom, with moveable partition wall
- Stage is level with MPR floor, which results in less visibility during performances (MPR was formerly tiered); low ceiling minimizes options

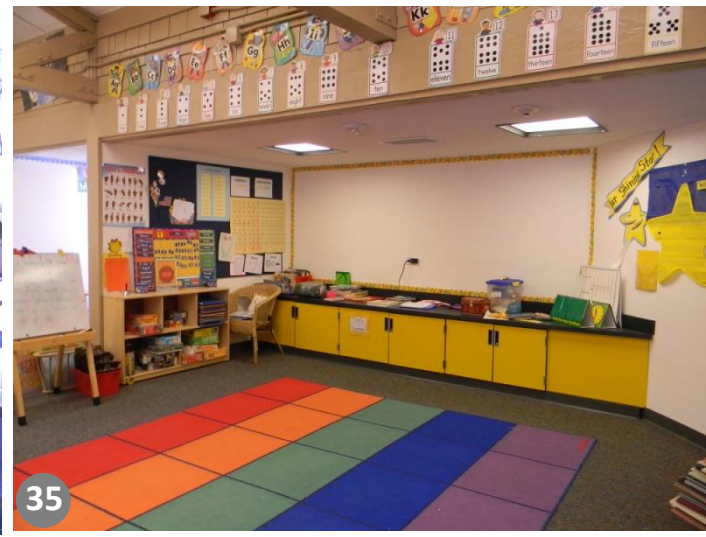
35 Typical Kindergarten Classroom

- 2 Kinder classrooms
- General classrooms grouped and connected to small, central collaboration/breakout space; these small areas have computer workstations (but do not accommodate ergonomic sitting)
- 10 portables being used as classrooms (1 for Music; 1 for Science); are not as functional as general classrooms
- Need for more small group space near classrooms to accommodate RTI groups
