CAMPUS OBSERVATIONS

Westpark Elementary School

25 San Carlo | Irvine, CA 92614 Site Analysis

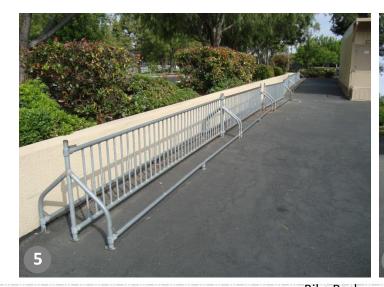
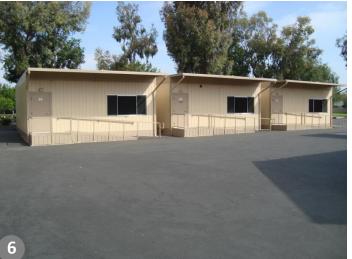
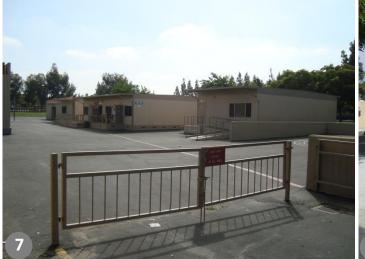
•Lack of adequate classroom space; 6 portables and 6 "permanent portables" used as classrooms

Classroom Portables

. Secondary entrance near Childcare Portables

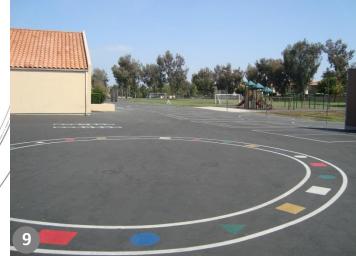
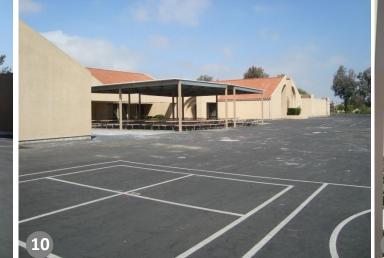
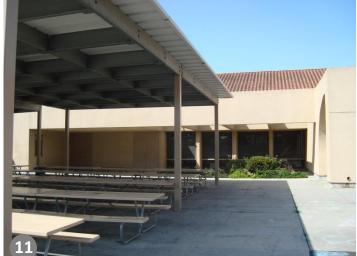
- •Small and inadequate
- •One (1) door for entry/ exit; small serving window; students do not have covered area and must queue and wait outside

Lunch Shelter

Lunch Shelter and overhang near food service

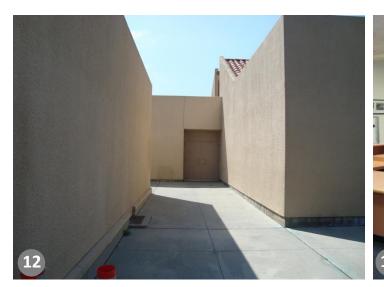
- •Building somewhat confusing to navigate; long dark hallways, disorienting layout; additional classrooms added to campus in seemingly unplanned manner
- •Areas between main building and "permanent portables" may be difficult to supervise
- •Adjacency to city park and spaces around portables result in increased need for supervision

Path between buildings (supervision concern)

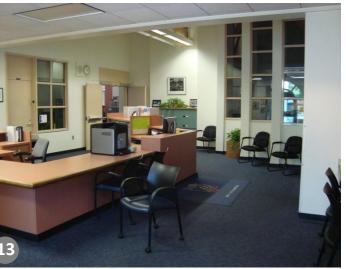
- •Workroom and staff lounge too small; only one workroom in school
- Principal's office too small
- •Front office described by staff as very open/distracting for completion of tasks
- •Conference room is small; accommodates no more than four people; currently use Special Education den room as conference space

Administrative Area and Waiting Area

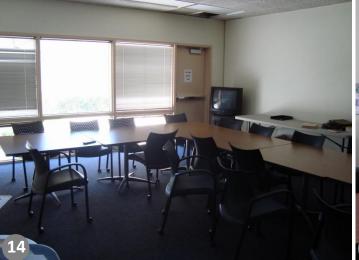
Staff Lounge

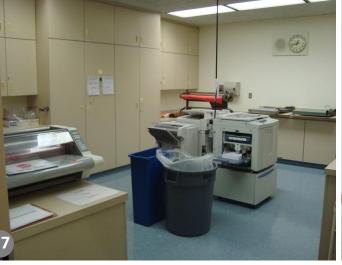
Staff Workroom

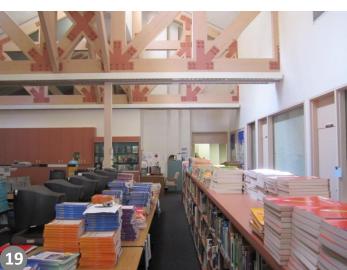
- •Centrally located, somewhat closer to grades 3-6 classrooms/pods
- •Described as being too small; preference for separation between library and media functions
- •Computer lab, the only one in the school, can only support one class, resulting in limited technology integration

Library

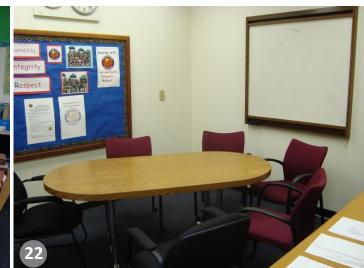
Conference Room

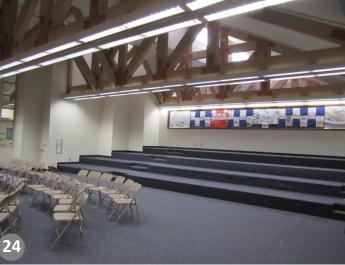
- •MPR and stage are adequate in size
- Inability to open to outdoor space
- •Stage cannot be used as acousticallyseparated classroom

MPR Stage and floor seating
